# CASE STUDY

## HOT WORK CONTROL AND SAFE WORK PRACTICES AT OIL AND GAS PRODUCTION WELLS

### PARTRIDGE-RALEIGH SMITH COUNTY OILFIELD

REPORT No. 2006-07-I-MS

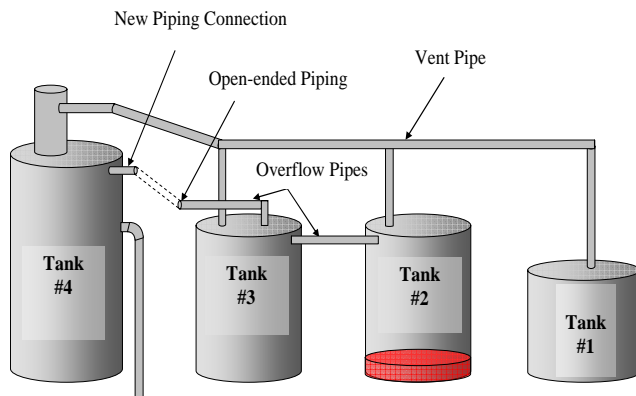
**Figure 1. Tanks involved in the incident**

In the weeks preceding the incident, Stringer's workers had relocated tanks 3 and 4 from other oilfield sites on the Partridge-Raleigh property to the #9 well site. On the day of the incident, the four workers were completing the piping connection between the tanks.

To connect the piping from tank 3 to tank 4, the workers had to weld a pipe fitting onto the side of, and a few inches below the top of, tank 4. To prepare for the welding operation, they removed the access hatch at the base of tank 4 and entered the tank to remove the crude oil residue. Then they

flushed the tank with fresh water and allowed hydrocarbon vapor to evaporate for several days. They did not clean out or purge tanks 2 and 3.

The explosion was fueled by flammable hydrocarbon vapor venting from an open-ended, three-inch diameter pipe extending from an adjacent tank to the tank where the welding was taking place. As the morning sun warmed tanks 2 and 3, the flammable vapor inside expanded, forcing it out through the overflow pipe. The pipes were not equipped with isolation valves and although the pipe was capable of being capped, no cap was installed (see Figure 1).

Stringer's workers did not isolate tanks 2 and 3, which contained flammable vapor, prior to beginning the welding operation. Additionally, the open-ended pipe of tank 3 was left uncapped and provided the source of hydrocarbon vapor. Workers did not clean tanks 2 and 3 or cap the end of the pipe prior to beginning the welding job on tank 4. If the residual oil in tank 2 had been removed and both tanks flushed with water, the flammable vapor source could have been eliminated.

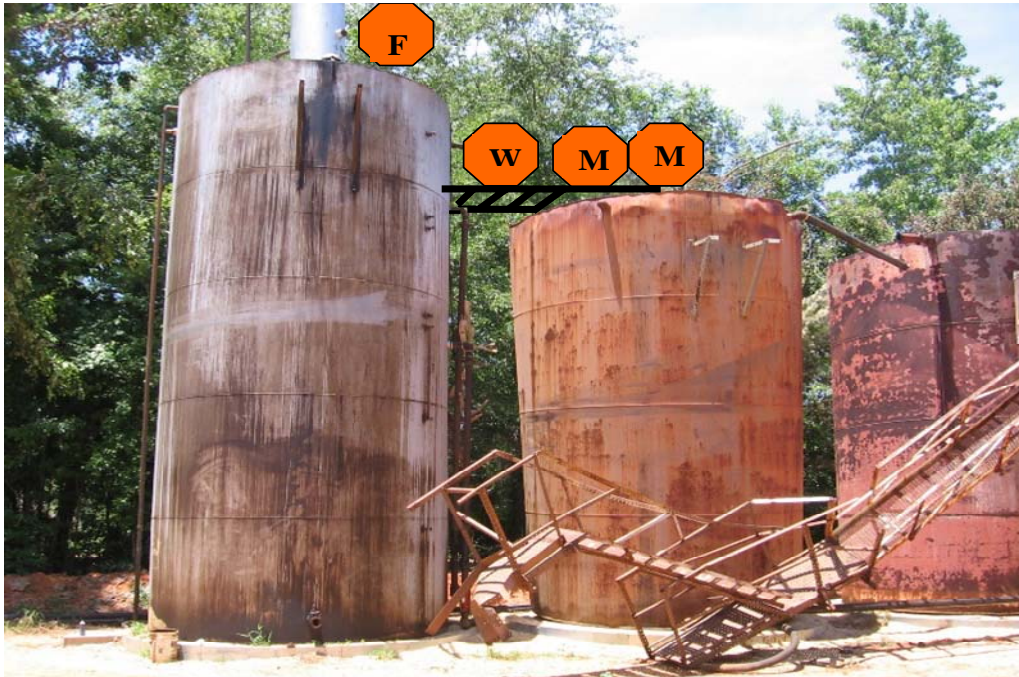
**Figure 2. Workers' location prior to incident**  
**(Note: the ladder was blown clear by the explosion)**

Next, the foreman (F) climbed to the top of tank 4 (figure 2). Two other maintenance workers, (M) climbed on top of tank 3; they then laid a ladder on the tank roof, extending it across the 4 foot space between tank 3 and 4, and held the ladder steady for the welder (W). The welder attached his safety harness to the top of tank 4 and positioned himself on the ladder.

Almost immediately after the welder started welding, flammable hydrocarbon vapor venting from the open-ended pipe that was attached to tank 3 ignited. The fire, which immediately flashed back into tank 3, spread through the overflow connecting pipe from tank 3 to tank 2, causing tank 2 to explode. The lids of both tanks were blown off.

The three workers atop the tanks were thrown by the force of the explosion and fell to the ground. The welder was also thrown off the ladder, but he was wearing a safety harness that prevented him from falling to the ground.

Rather than construct a scaffold for the welder, the contractor crew used a ladder laid flat from atop an adjacent tank and extended it over to the tank being welded. The makeshift work platform required two crew members to stand on top of tank 3 to brace the ladder in place while the welder worked. The other crew member stood on top of tank 4. Two of the fatalities could have been avoided if the workers were not standing on top of tank 3.

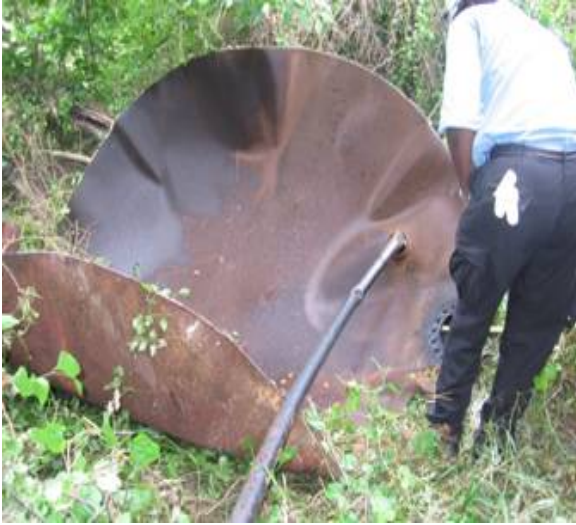
**Figure 3. Tank 2 lid**

Witnesses observed flames as high as 50 feet above tank 2, but no flames above tanks 3 or 4. The fire department applied foam to the burning oil fire inside tank 2 and extinguished the fire in about 30 minutes.

The top of tank 2 (Figure 3) landed about 250 yards away, and the top from tank 3 (Figure 4) landed about 50 feet away. Approximately 1000 gallons of crude oil remained inside tank 2 after the incident; tank 3 contained about 650 gallons of residue. Tanks 1 and 4 sustained no visible damage.

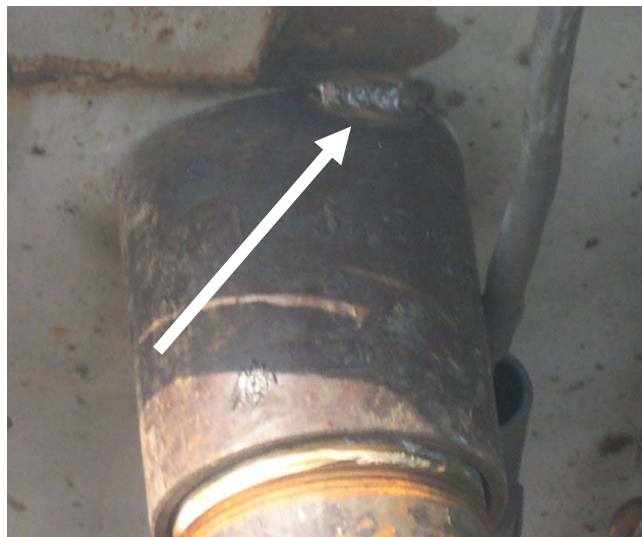
**Figure 5. Tack weld and connection being welded to tank 4**

The explosion was ignited by the welding being done on the side of tank 4. The CSB confirmed through interviews and examination of the tanks that the welder had applied two small tack welds to the pipe fitting on tank 4 shortly before the explosion (figure 5).

The welder stated that within seconds of applying the tack welds a fire ignited and an explosion occurred.

The CSB concluded that the welding sparks ignited flammable vapor venting from the open-ended pipe of tank 3. Flames from this ignition spread into tank 3, causing it to

explode. Then vapor inside tank 2 ignited followed by the explosion of the tank.

- Isolate the area to be welded from any piping or tanks that contain flammable or combustible liquids, vapors, or residues by installing caps, blinds (blanks),<sup>2</sup> plugs or other devices to physically isolate the piping including vents.

- Perform a flammable gas test before and during welding using a flammable gas detector.
- Remove flammable or combustible liquids, vapors, and residues from tanks and all associated piping.
